2nd Brigade Barracks Complex – Phase 1 and 2

**Volume V of VI – Asbestos Surveys and
Hazardous Building Materials Surveys**

Asbestos Survey

**Building No. 5430 Fort Bragg, North
Carolina**

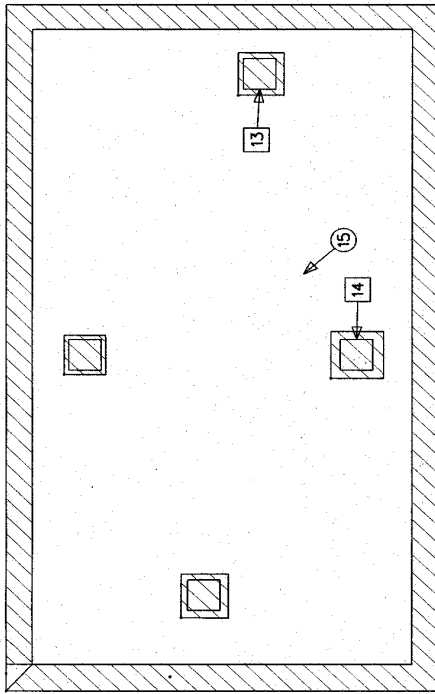
ROOF SAMPLE LOCATIONS

- b. Roofing Materials:* The roof of building 5630 is constructed of a multi-layered tar and felt membrane over foam-glass insulation. The tar and felt flashing materials and cements at the roof penetrations contain or are assumed to contain asbestos. The main roof field was analyzed and found to be non-asbestos containing. The flashing area around the perimeter of the roof, from the edge in to approximately 3 feet, is assumed to contain asbestos based on inspections of similar buildings. - (Refer to Tables 1, 2 and 3 for specific information and Figure 1 for sample locations and homogeneous area locations).
